## INDEPENDENT VEHICLE INSPECTION REPORT

*Jaguar E-Type Series 1 4.2 OTS*

1967 Jaguar E-Type Series 1 4.2 OTS

Inspection date: 24 July 2026

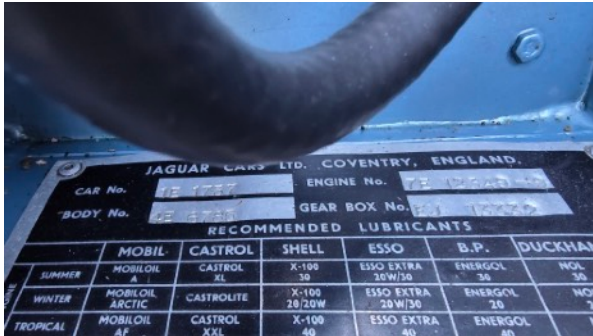
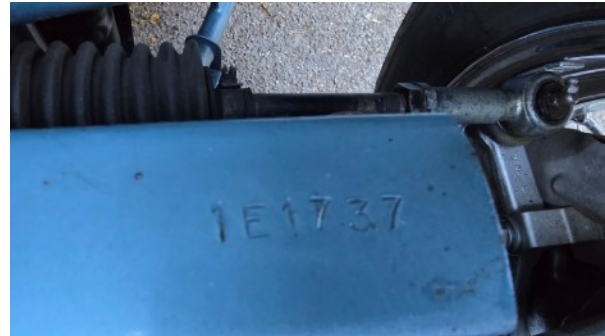
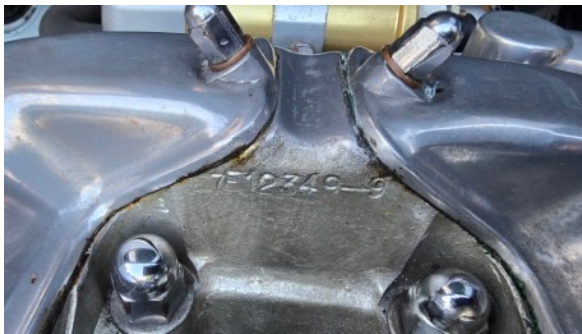
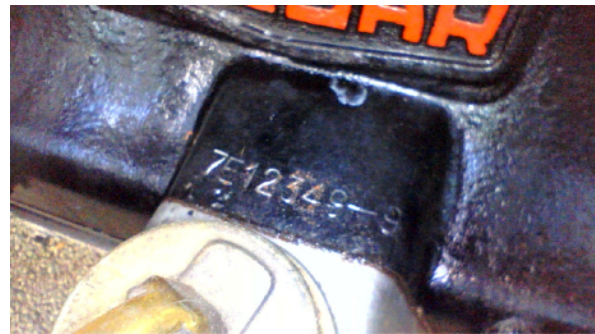
The vehicle identity was examined using the identification markings present on the car and compared with the available documentation.

The identification markings inspected are consistent with the vehicle's recorded identity. The chassis and engine number stampings examined showed no apparent indication of alteration at the time of inspection.

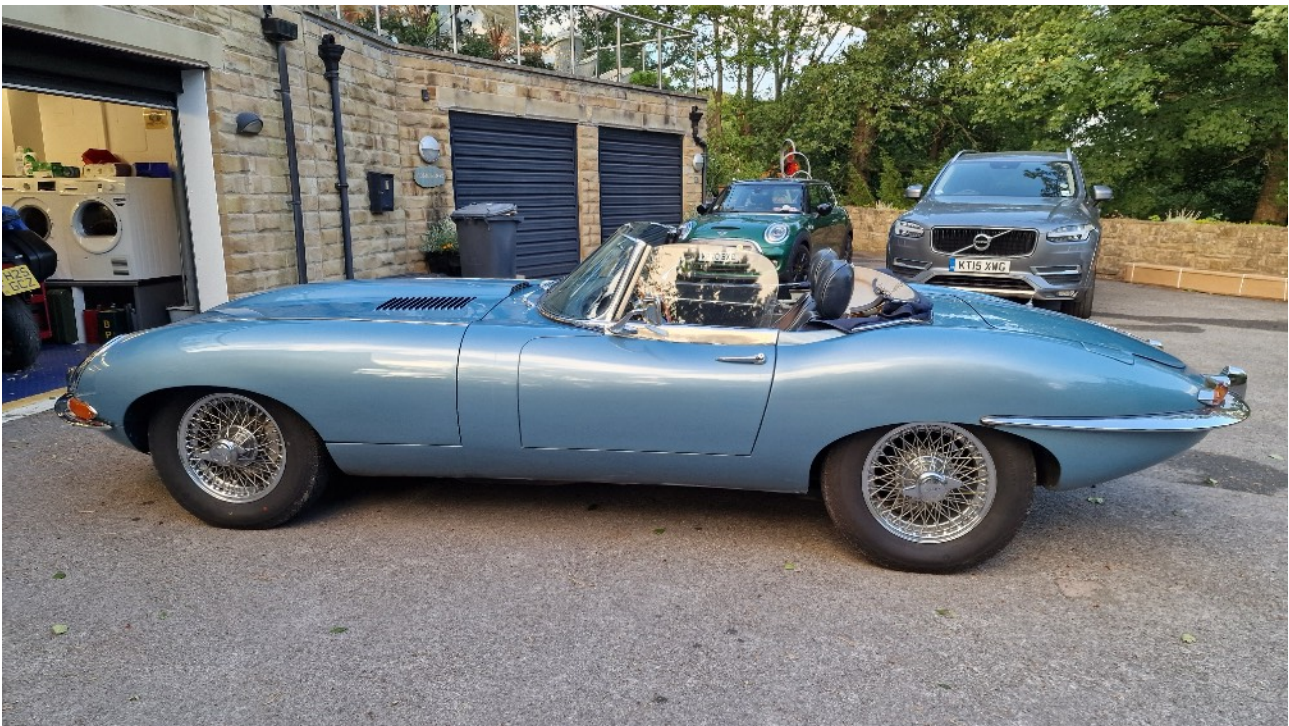
Paint-thickness measurements showed substantial variation around the known repair forward of the right-hand rear wheel arch. Readings across the front bodywork were more consistent. No obvious corrosion was identified in this area. A scratch is present on the right-hand front wing, reportedly caused by contact with one of the owner's motorcycles.

*Body and paintwork. Localised previous repair is present forward of the right-hand rear wheel arch.*

Paint-thickness measurements showed considerable variation across the body, with particularly high and varying readings around the known repair forward of the right-hand rear wheel arch.

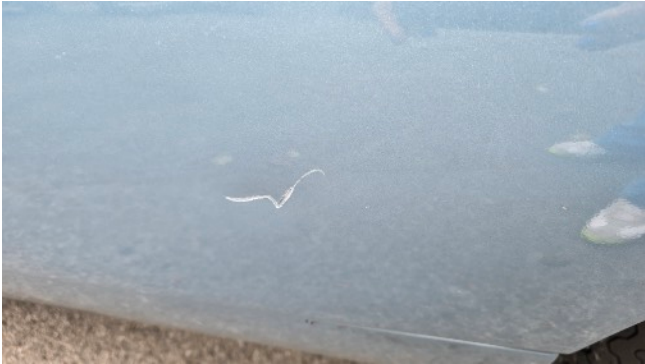
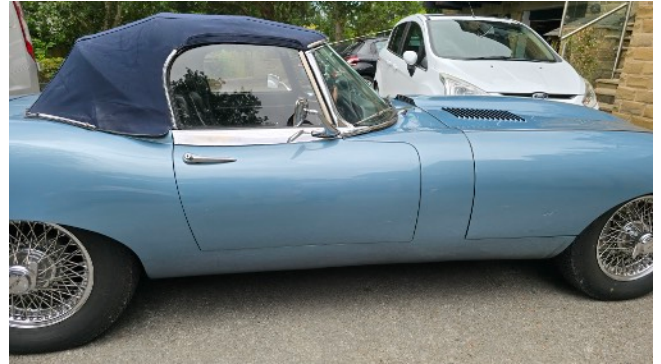
Previous damage and filler are present forward of the right-hand rear wheel arch, consistent with the known repair.

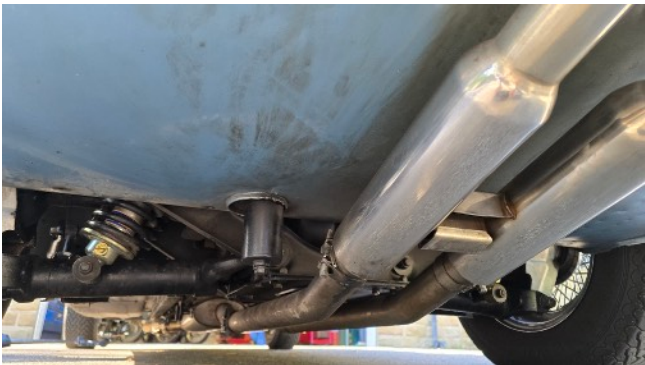
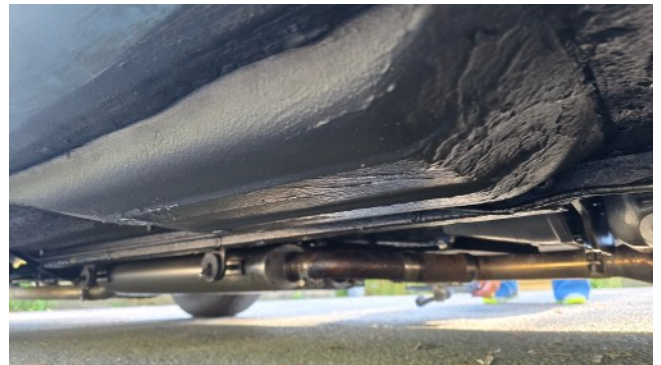
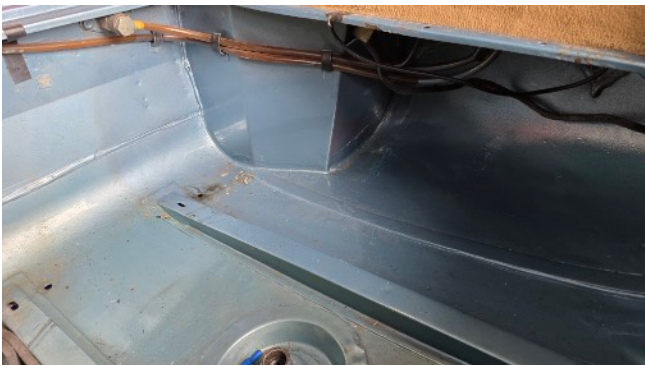
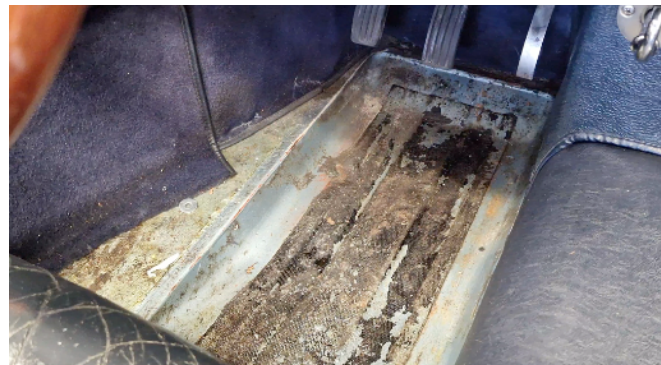
The accessible underside, floors, luggage compartment and structural areas appeared generally sound, with no obvious significant corrosion identified during the inspection.

*Accessible floor, footwell and luggage compartment areas examined during inspection.*

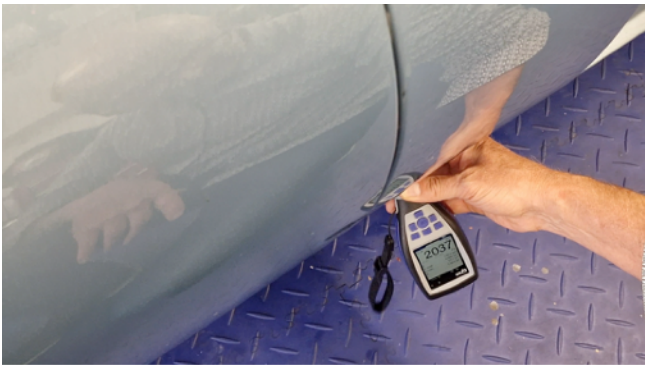
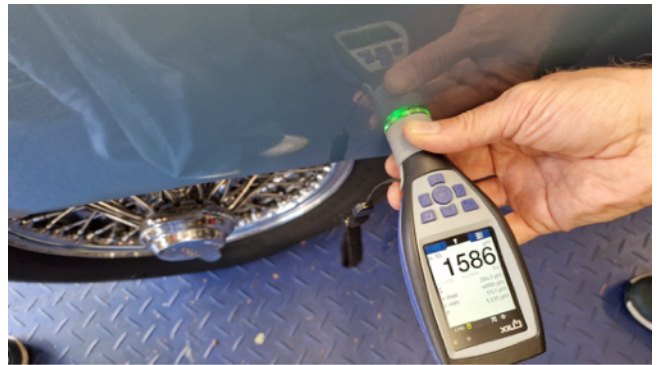
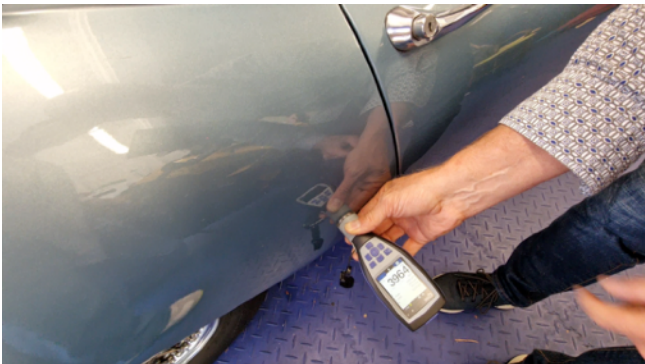
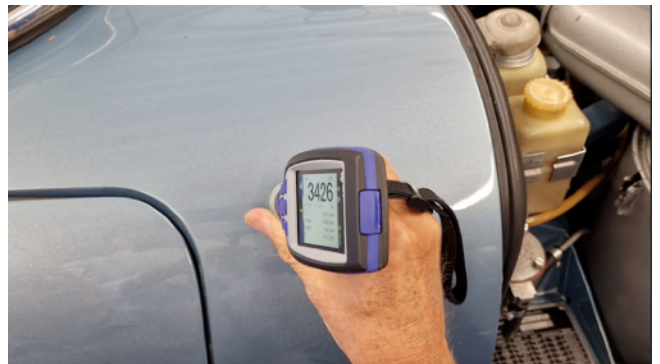
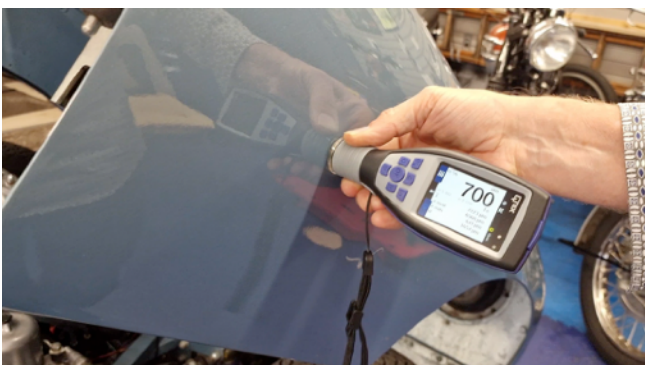
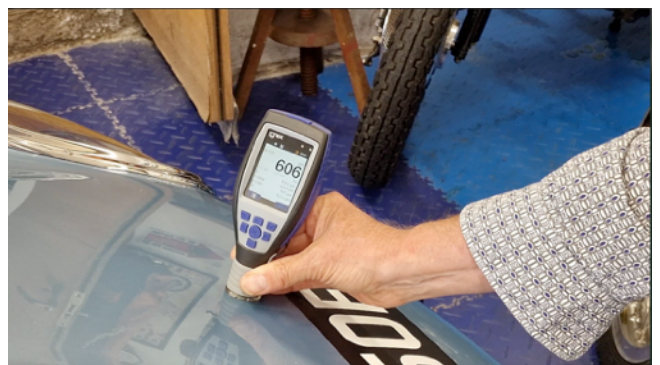
*Selected paint-thickness measurements across the body.*

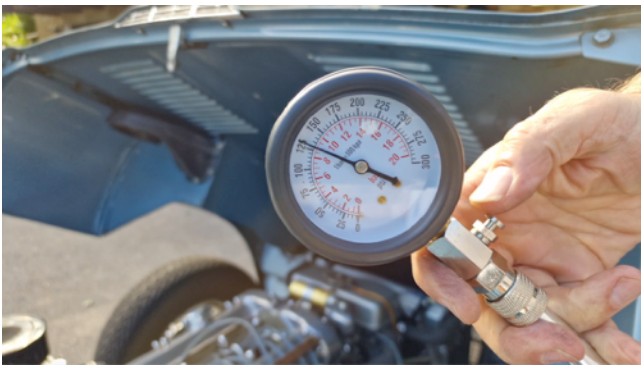
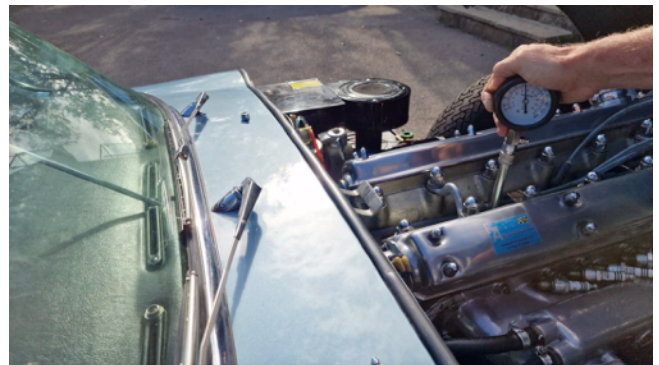
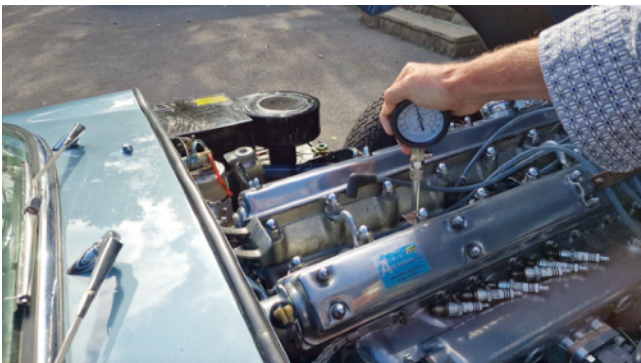
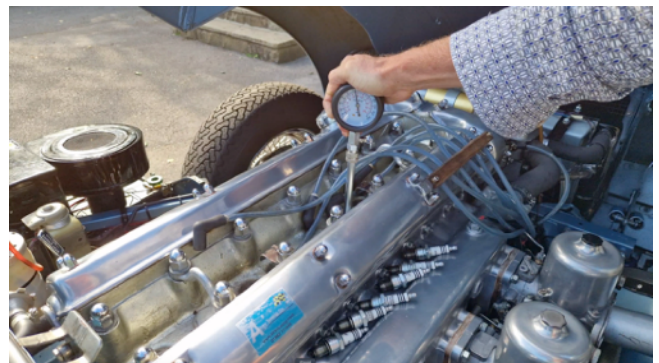
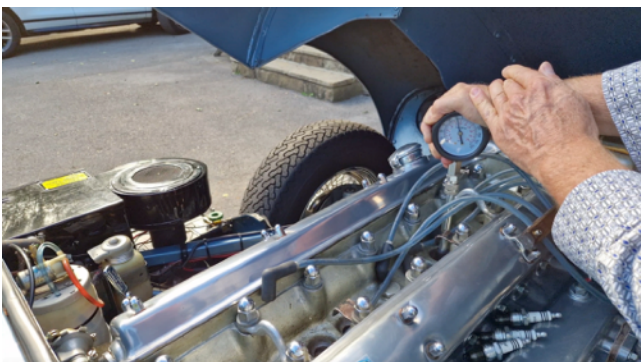
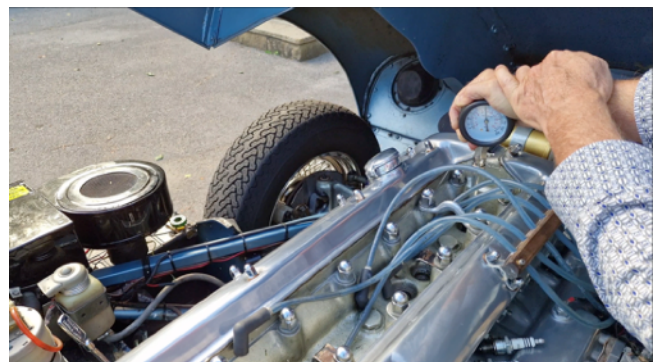
A compression test was carried out across all six cylinders to provide an indication of cylinder sealing and the general mechanical condition of the engine. The readings were closely consistent across all six cylinders.

*Compression readings: All six cylinders recorded between approximately 9.0 and 9.2 bar, with no significant variation between individual cylinders.*

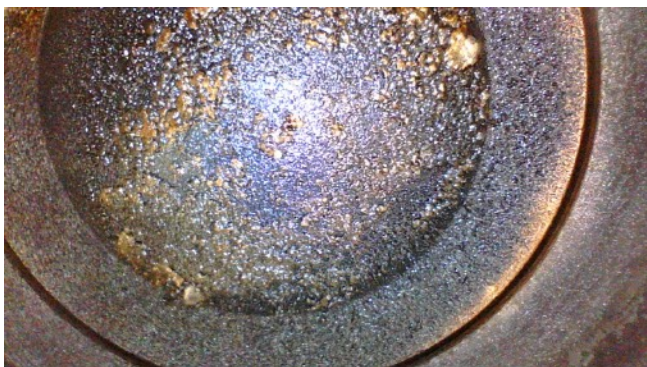
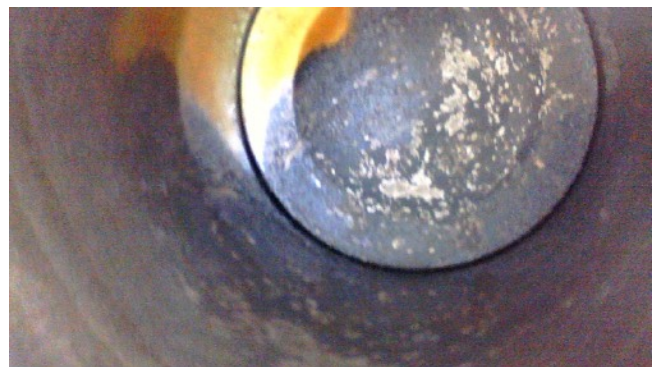
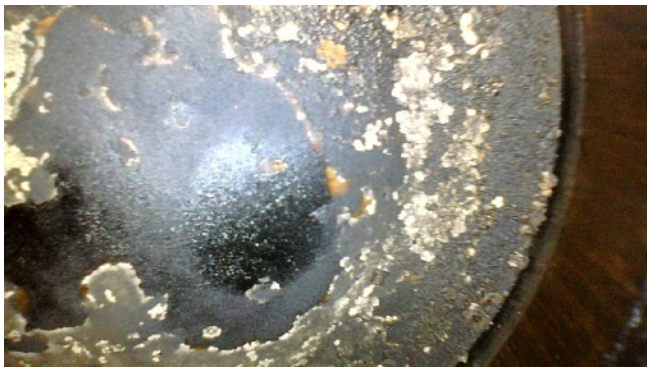
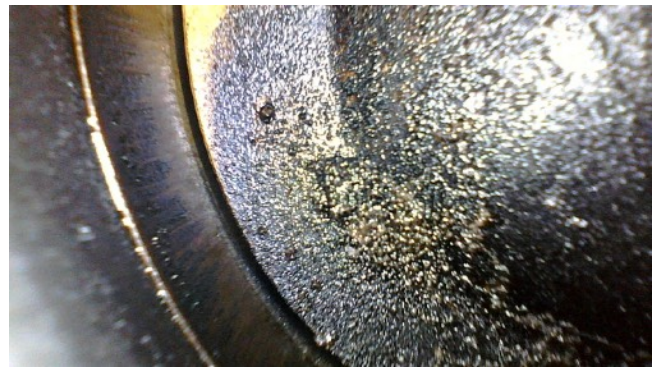
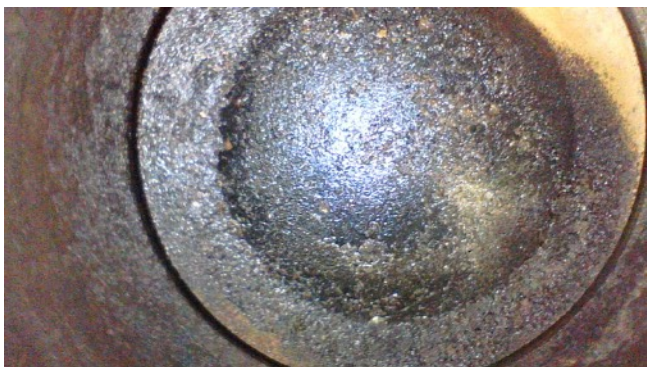
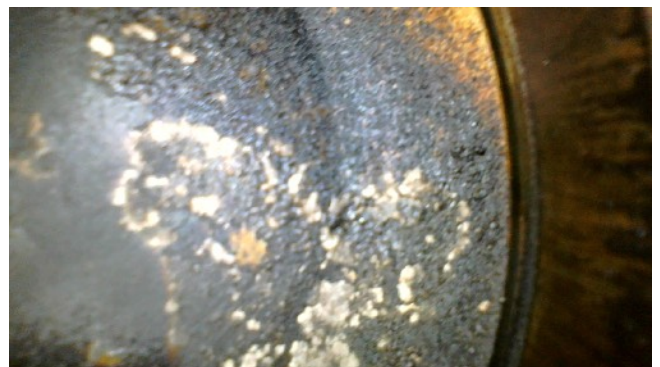
The combustion chambers and piston crowns were visually examined by borescope through the spark-plug openings. Varying levels and patterns of combustion deposits were observed between the six cylinders. In view of these differences, carburettor balance and mixture settings should be checked.

No obvious evidence of significant mechanical damage was identified during the visual inspection. These observations should be considered together with the compression test, which showed consistent readings across all six cylinders.

*Borescope views of the six combustion chambers and piston crowns. Differences in combustion-deposit patterns are visible between cylinders.*

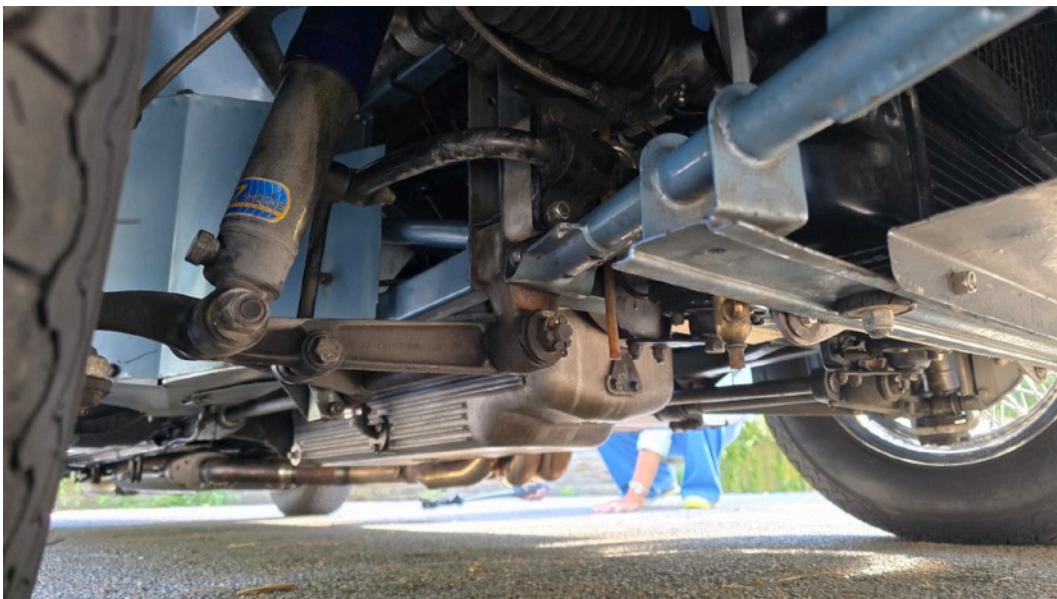
The front suspension and steering components were visually inspected, including the wishbones, ball joints, bushes, dampers and accessible mounting points. The installation appeared generally well maintained, with no obvious defects identified during the visual inspection.

The car is fitted with polyurethane suspension bushes throughout, GAZ adjustable shock absorbers and replacement upper wishbones incorporating upgraded CMC ball joints. Steering operation and behaviour were assessed during the road test.

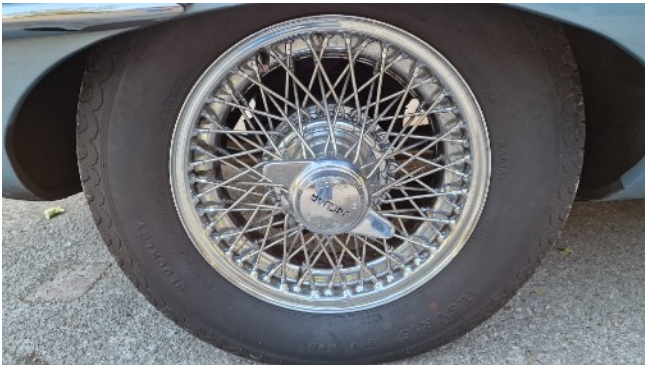
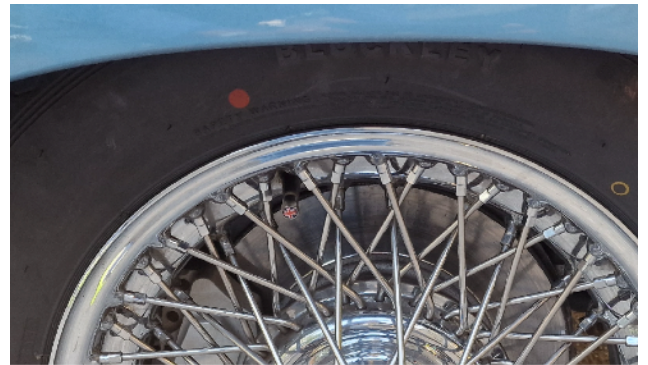
The car is fitted with Dayton chrome wire wheels and replacement splined hubs. The front wheel bearings have also been replaced.

Blockley tyres are fitted, with the rear tyres dating from 2022 and the front tyres from 2026. The wheels, tyres and accessible hub areas were visually inspected during the assessment.

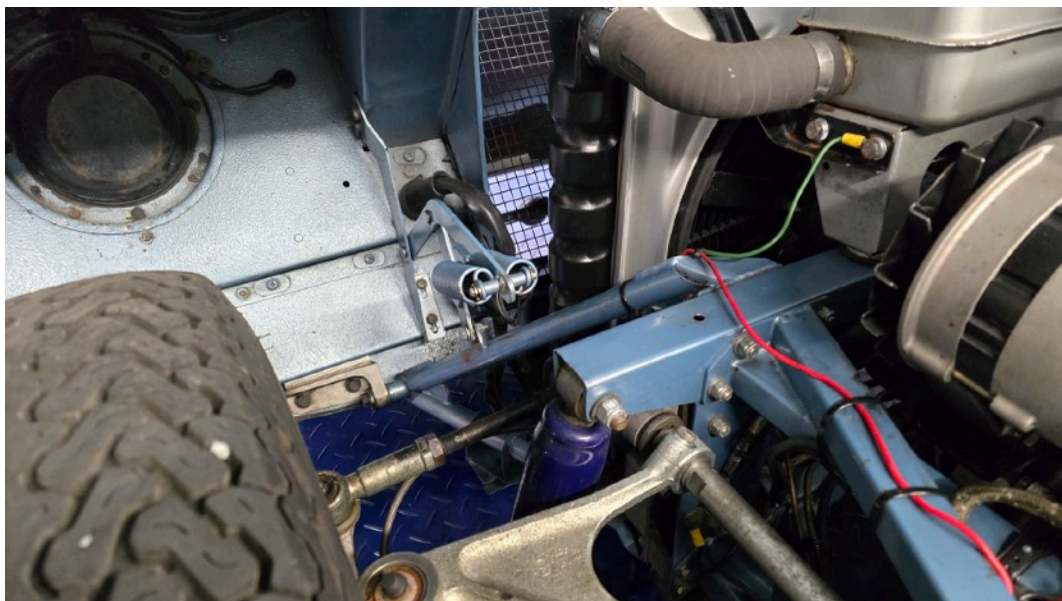
The cooling system has been upgraded with a Fosseway aluminium radiator and electric fan assembly, Kevlar coolant hoses and an aluminium water pump.

In addition to the thermostatically controlled cooling fan, a separate manual override has been incorporated. This is discreetly operated through the low-speed position of the interior heater-fan switch.

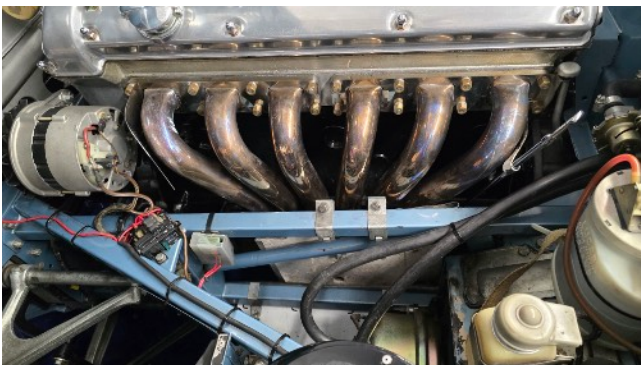
*Engine bay showing the tubular exhaust manifolds forming part of the Classic Fabs exhaust installation.*

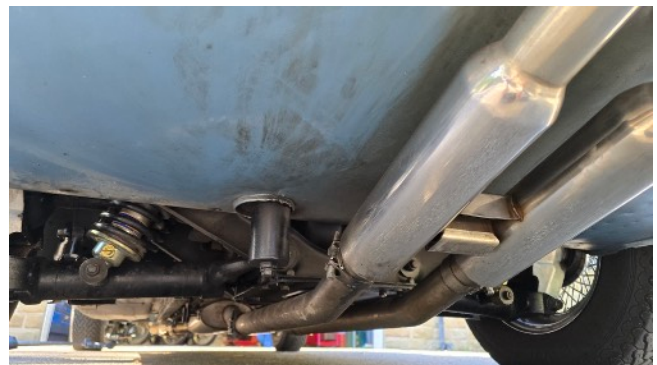
The car is fitted with a Classic Fabs stainless-steel exhaust system of 2-inch diameter, including associated mountings. The system was installed in 2022. The previously removed exhaust manifold has been retained and accompanies the vehicle.

*Classic Fabs stainless-steel exhaust system and underside installation.*

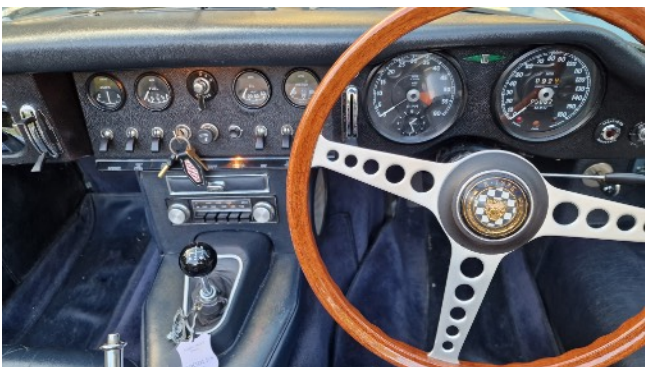
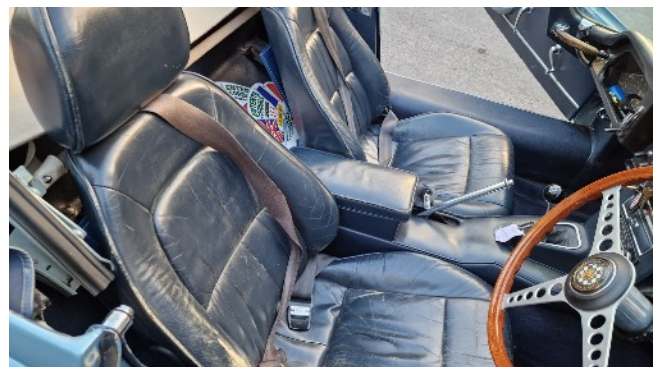
The dark blue soft top and matching tonneau cover are present and were inspected fitted to the vehicle. The tonneau cover was fitted by Eagle when the car was purchased in 1995 and therefore forms part of the car's presentation throughout the current ownership. Both remain in good serviceable condition, with signs of age and use consistent with more than three decades of regular use.

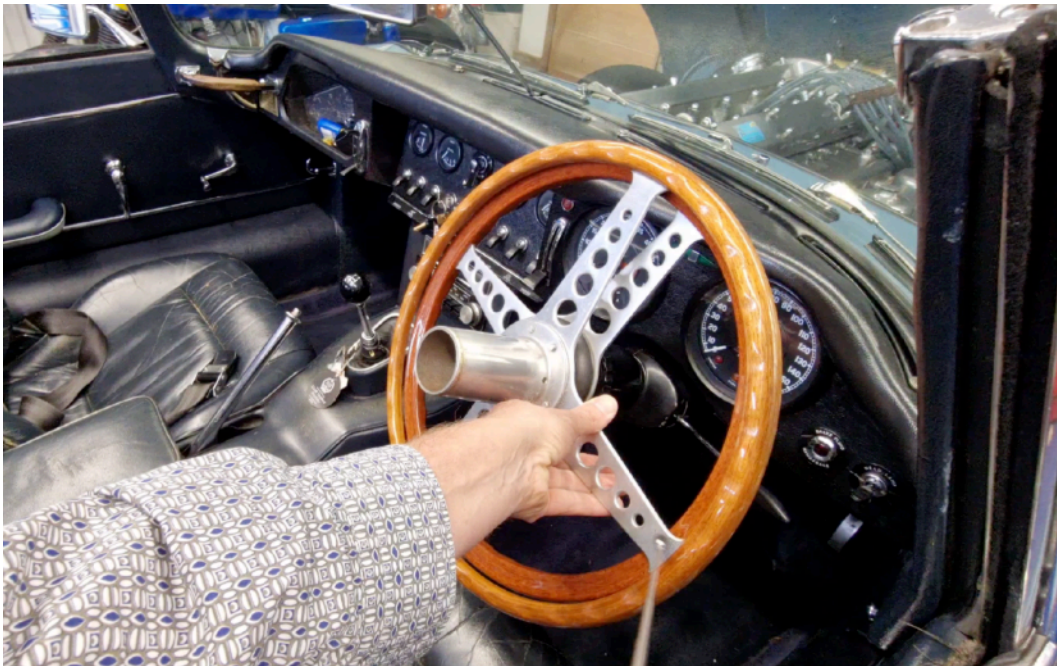
The car is fitted with a smaller-diameter wood-rim steering wheel in place of the standard steering wheel. The original steering wheel has been retained and accompanies the vehicle.

*Smaller-diameter 15-inch wood-rim steering wheel and driver's cockpit*

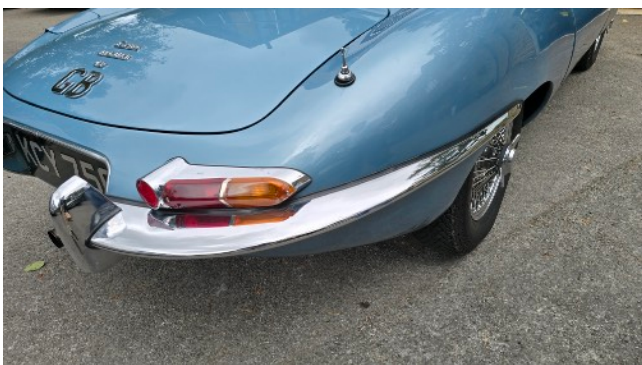
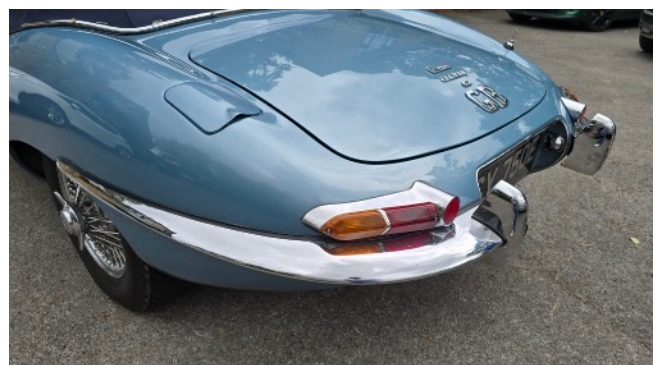
The exterior brightwork remains in notably good overall condition. The front and rear bumpers, overriders, headlamp surrounds, lamp housings, door handles, mirrors, windscreen surround and other chrome fittings retain a strong and generally even appearance.

Closer inspection reveals light marking, small imperfections and local deterioration to some chrome surfaces, together with minor wear to individual fittings. Overall, however, the brightwork remains well preserved and visually consistent across the car.

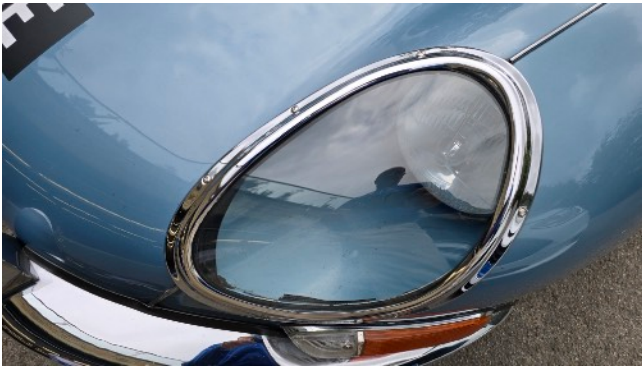
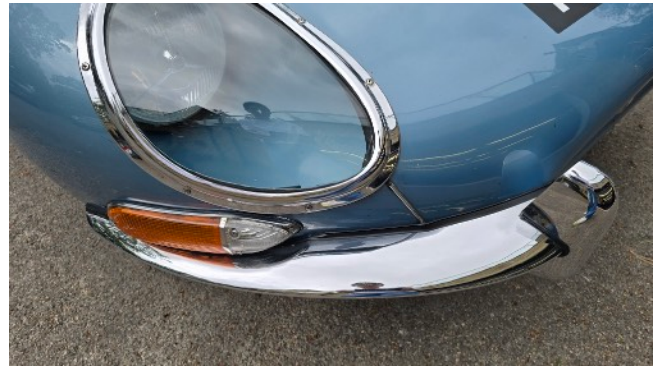
The covered headlamp assemblies present particularly well. The glass covers, chrome surrounds and lighting units are complete and well integrated into the bonnet. The front and rear lamp assemblies likewise appear complete and remain in good condition.

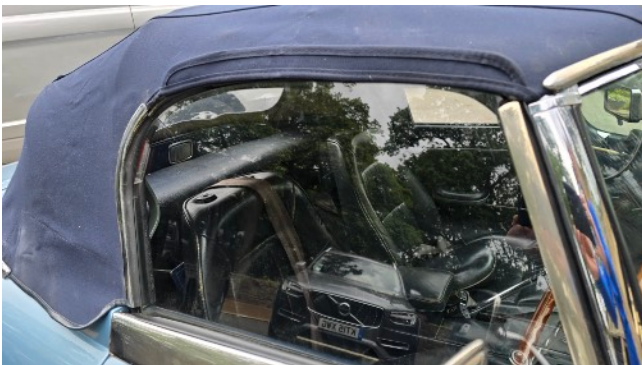
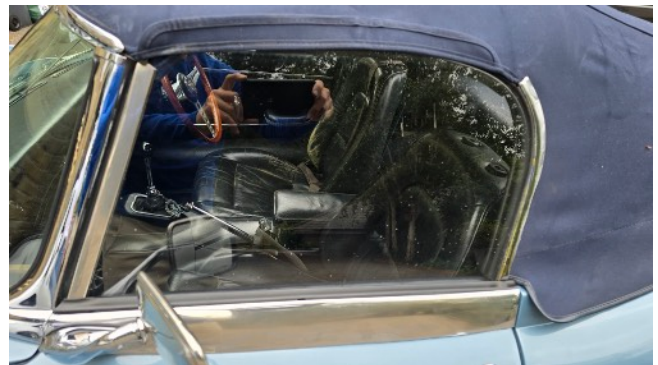
The glazing fitted to the car is replacement glass and is no longer the original factory-fitted glazing. It was inspected and presented in generally good condition.

The windscreen remains serviceable and presents well overall, while showing age- and use-related marking, including a clearly visible scratch on the driver's side. The surviving Eagle windscreen sticker provides a visible connection with the car's purchase from Eagle in 1995.

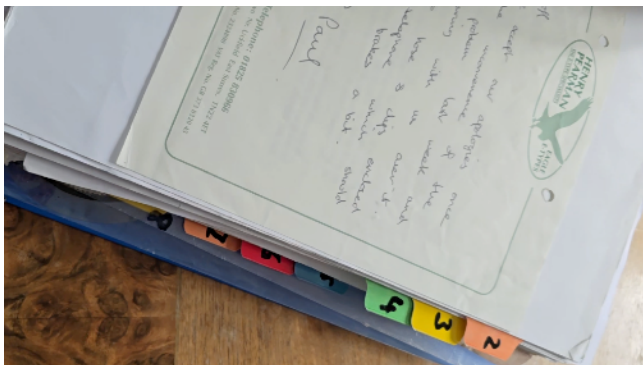
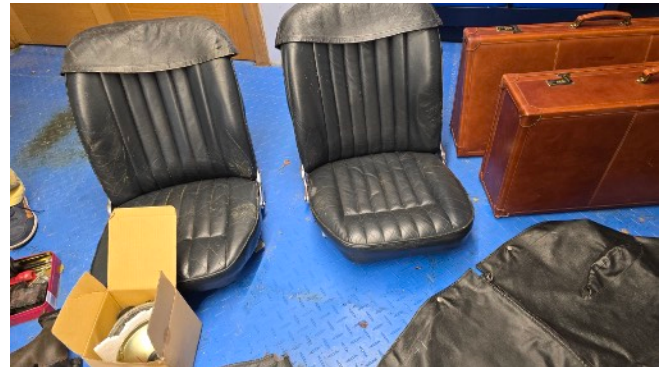
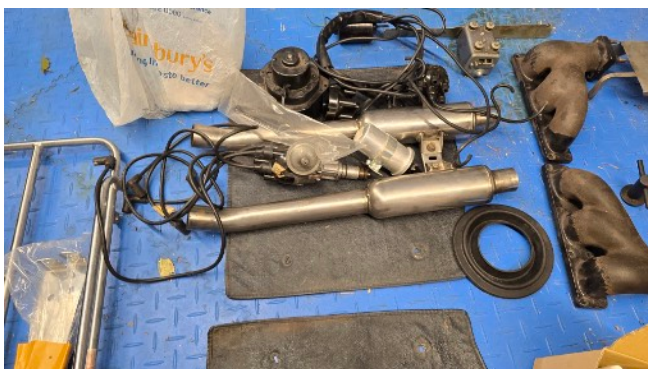
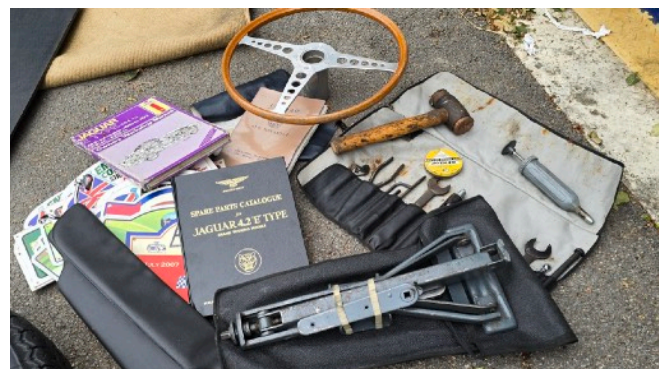
*Selection of retained original components, accessories, tools and documentation accompanying the vehicle.*
